Initial Analyses of Eagle River Flats Hydrology and Sedimentology, Fort Richardson, Alaska

Daniel E. Lawson, Susan R. Bigl, John H. Bodette and
Patricia Weyrick

March 1995

Prepared for
U.S. ARMY ENGINEER DISTRICT, ALASKA

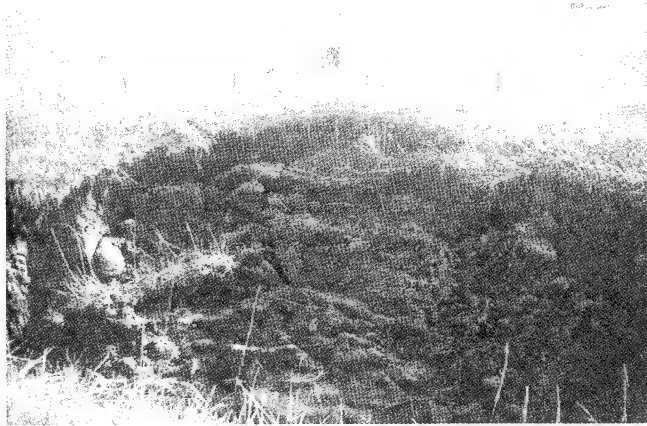
Figure 9. Headwall erosion study site. The line of stakes approximately parallels the gully crest. The hub stake is to the right of center behind the stake line.

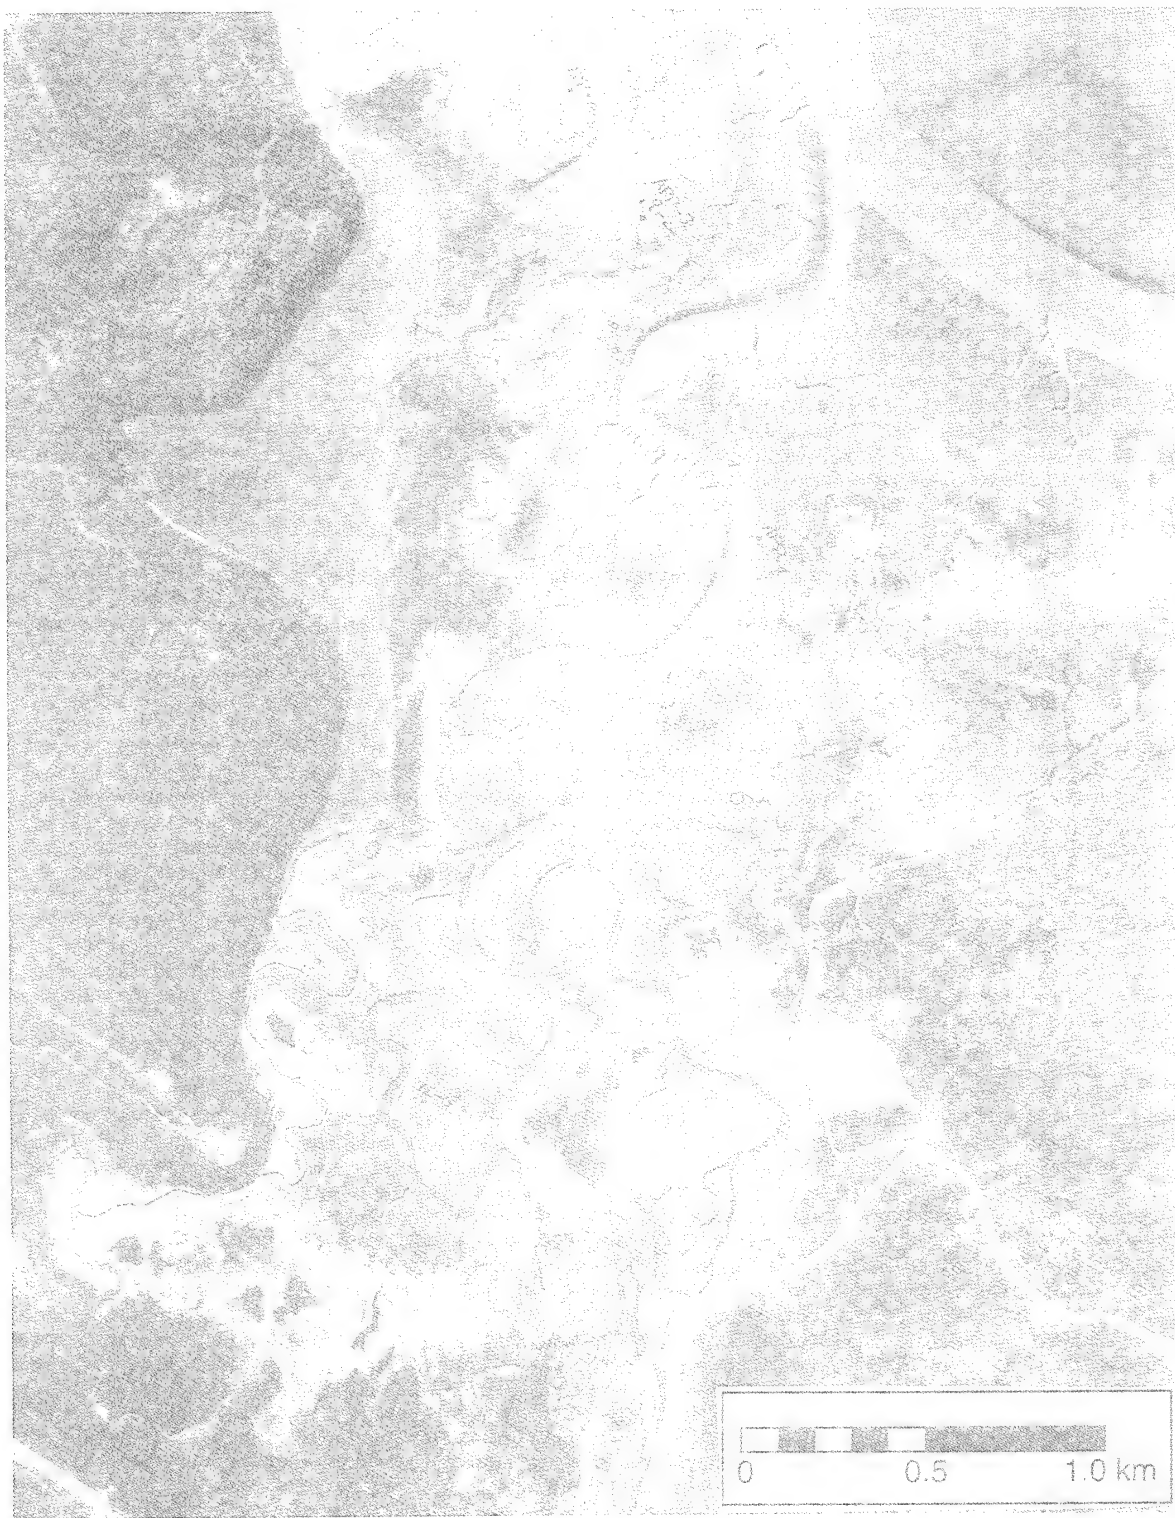
a. 1950.

Figure 13. Aerial photographs of ERF.

b. 1967.

c. 1993.

Aerial photographs from 1950, 1967 and 1993 reveal that the primary river channel (of three) was abandoned sometime between 1950 and 1967 (Fig. 13). By 1967, two channels diverged from Eagle River north of the Route Bravo bridge, the primary avenue of discharge now appearing to be the eastern course. Our initial review of these photographs does not reveal the cause of this change; however, it is clearly important to understanding the hydrology and sedimentology of the Flats.
